Memorandum

Re: *Environmental Desktop Review
Pleasant Park Site
Tonka Bay, Minnesota
WSB Project No.: 1987-570*

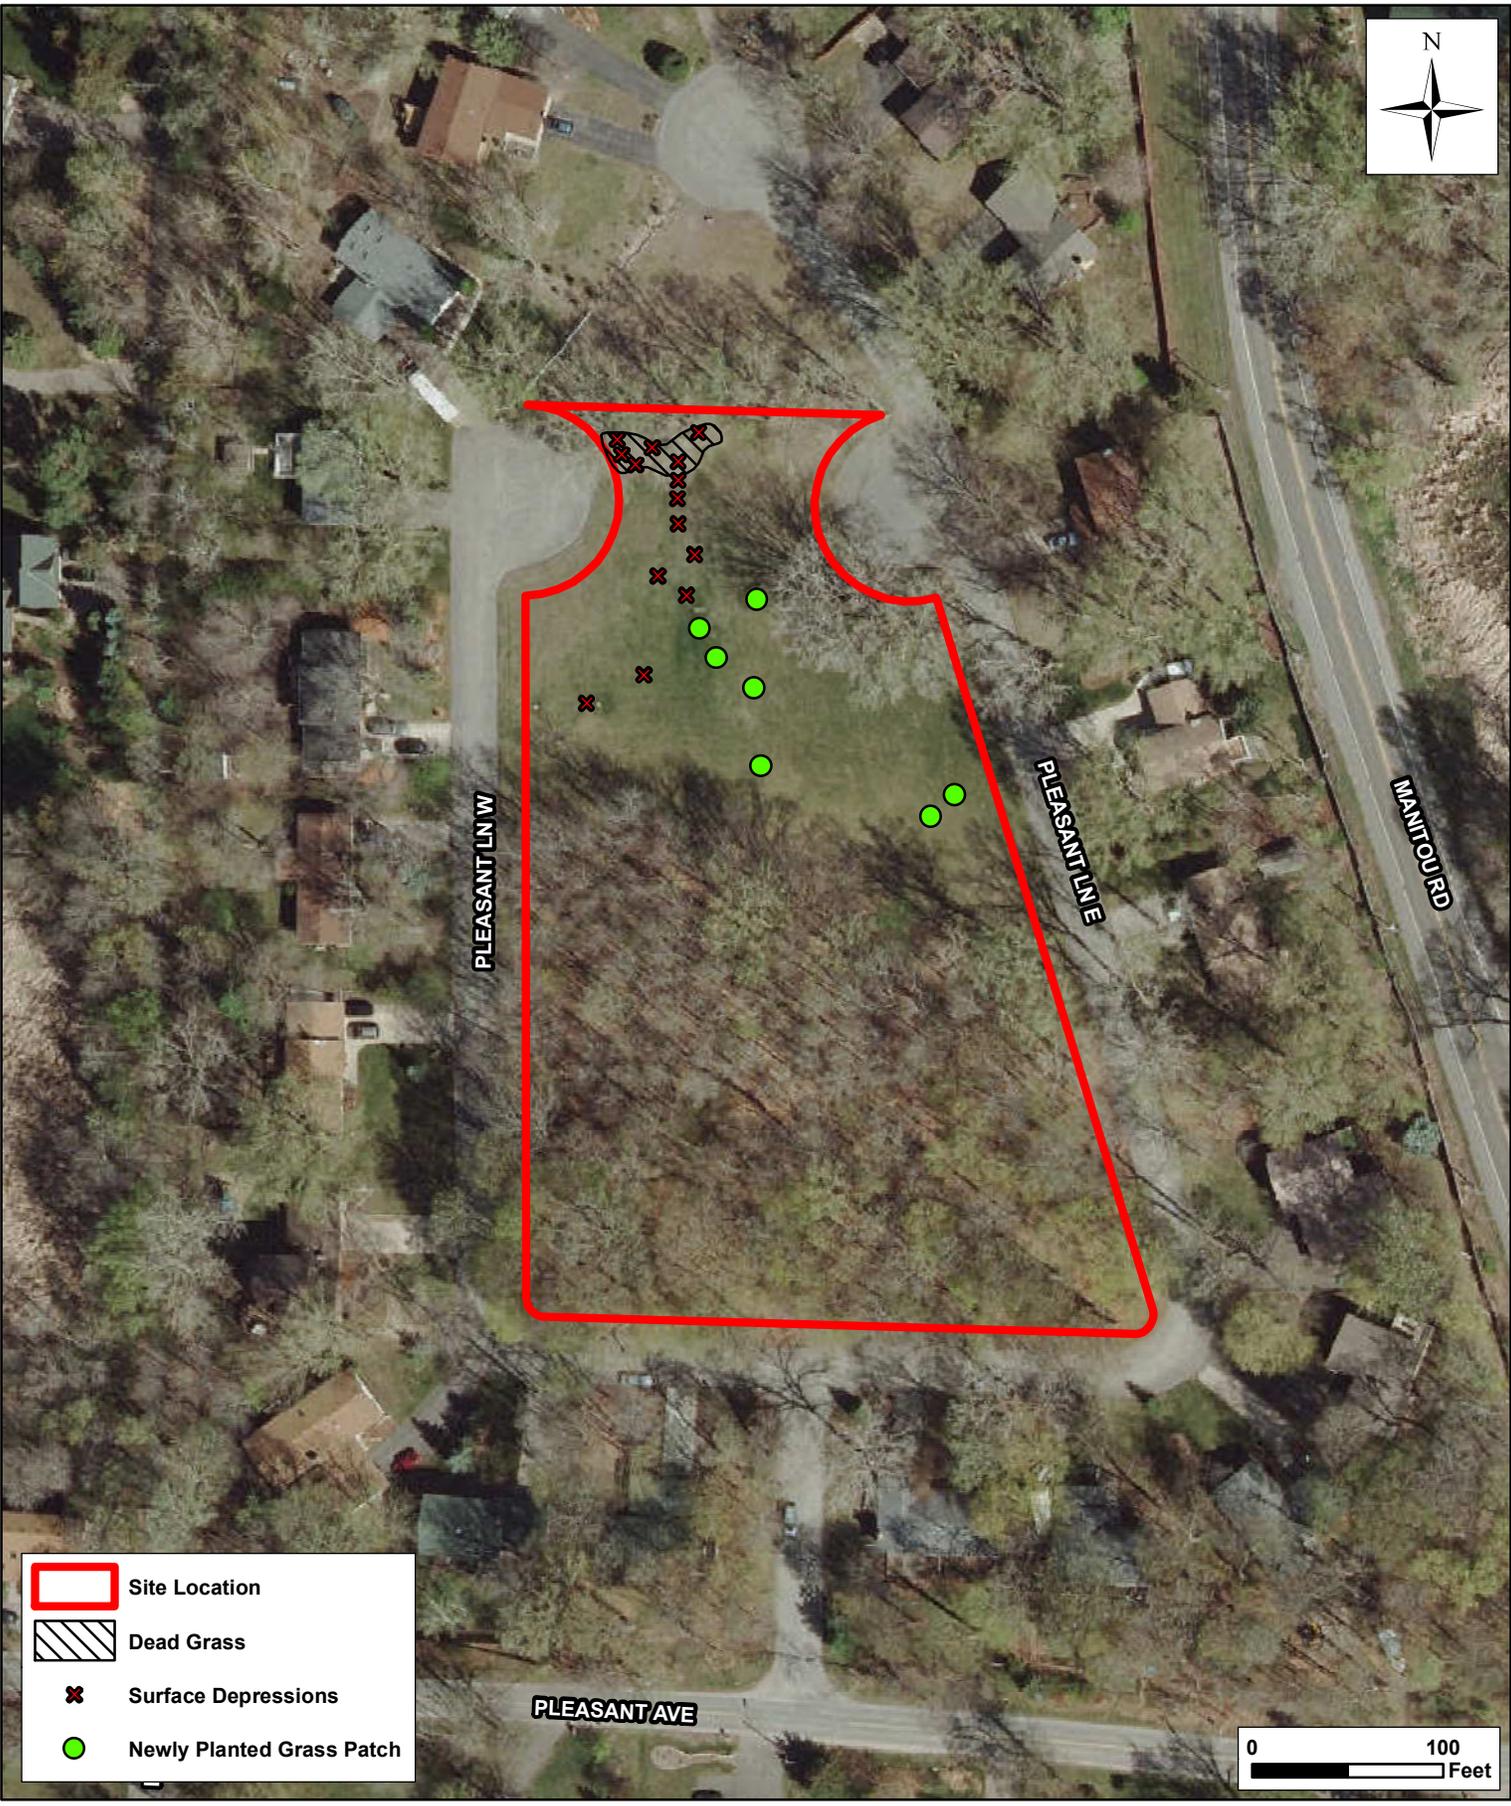
**Figure 2: Pleasant Park
Property Detail Map**
Tonka Bay, MN

Dead Grass

Surface Depressions

Newly Planted Grass Patch

- Patches of new grass and top soil were present throughout the northern half of the Property.
- Numerous scattered depressions and uneven terrain were observed at the northern portion of the Property which continued to the northern vacant parcel.
- A large area of bare soil was observed in a depression at the northwest corner of the Property.
- Two standpipes were observed at the vacant parcel north of the Property, which according to the City, are cleanouts for the City's sewer lines.

The site reconnaissance identified a number of depressions, fill areas and areas of distressed or dead vegetation. These areas appear to coincide with areas of historical gravel mining at the northern half of the Property. It is likely that the sinkhole formations at the Property are associated with poor or inadequate fill materials used to fill/restore the mining areas.

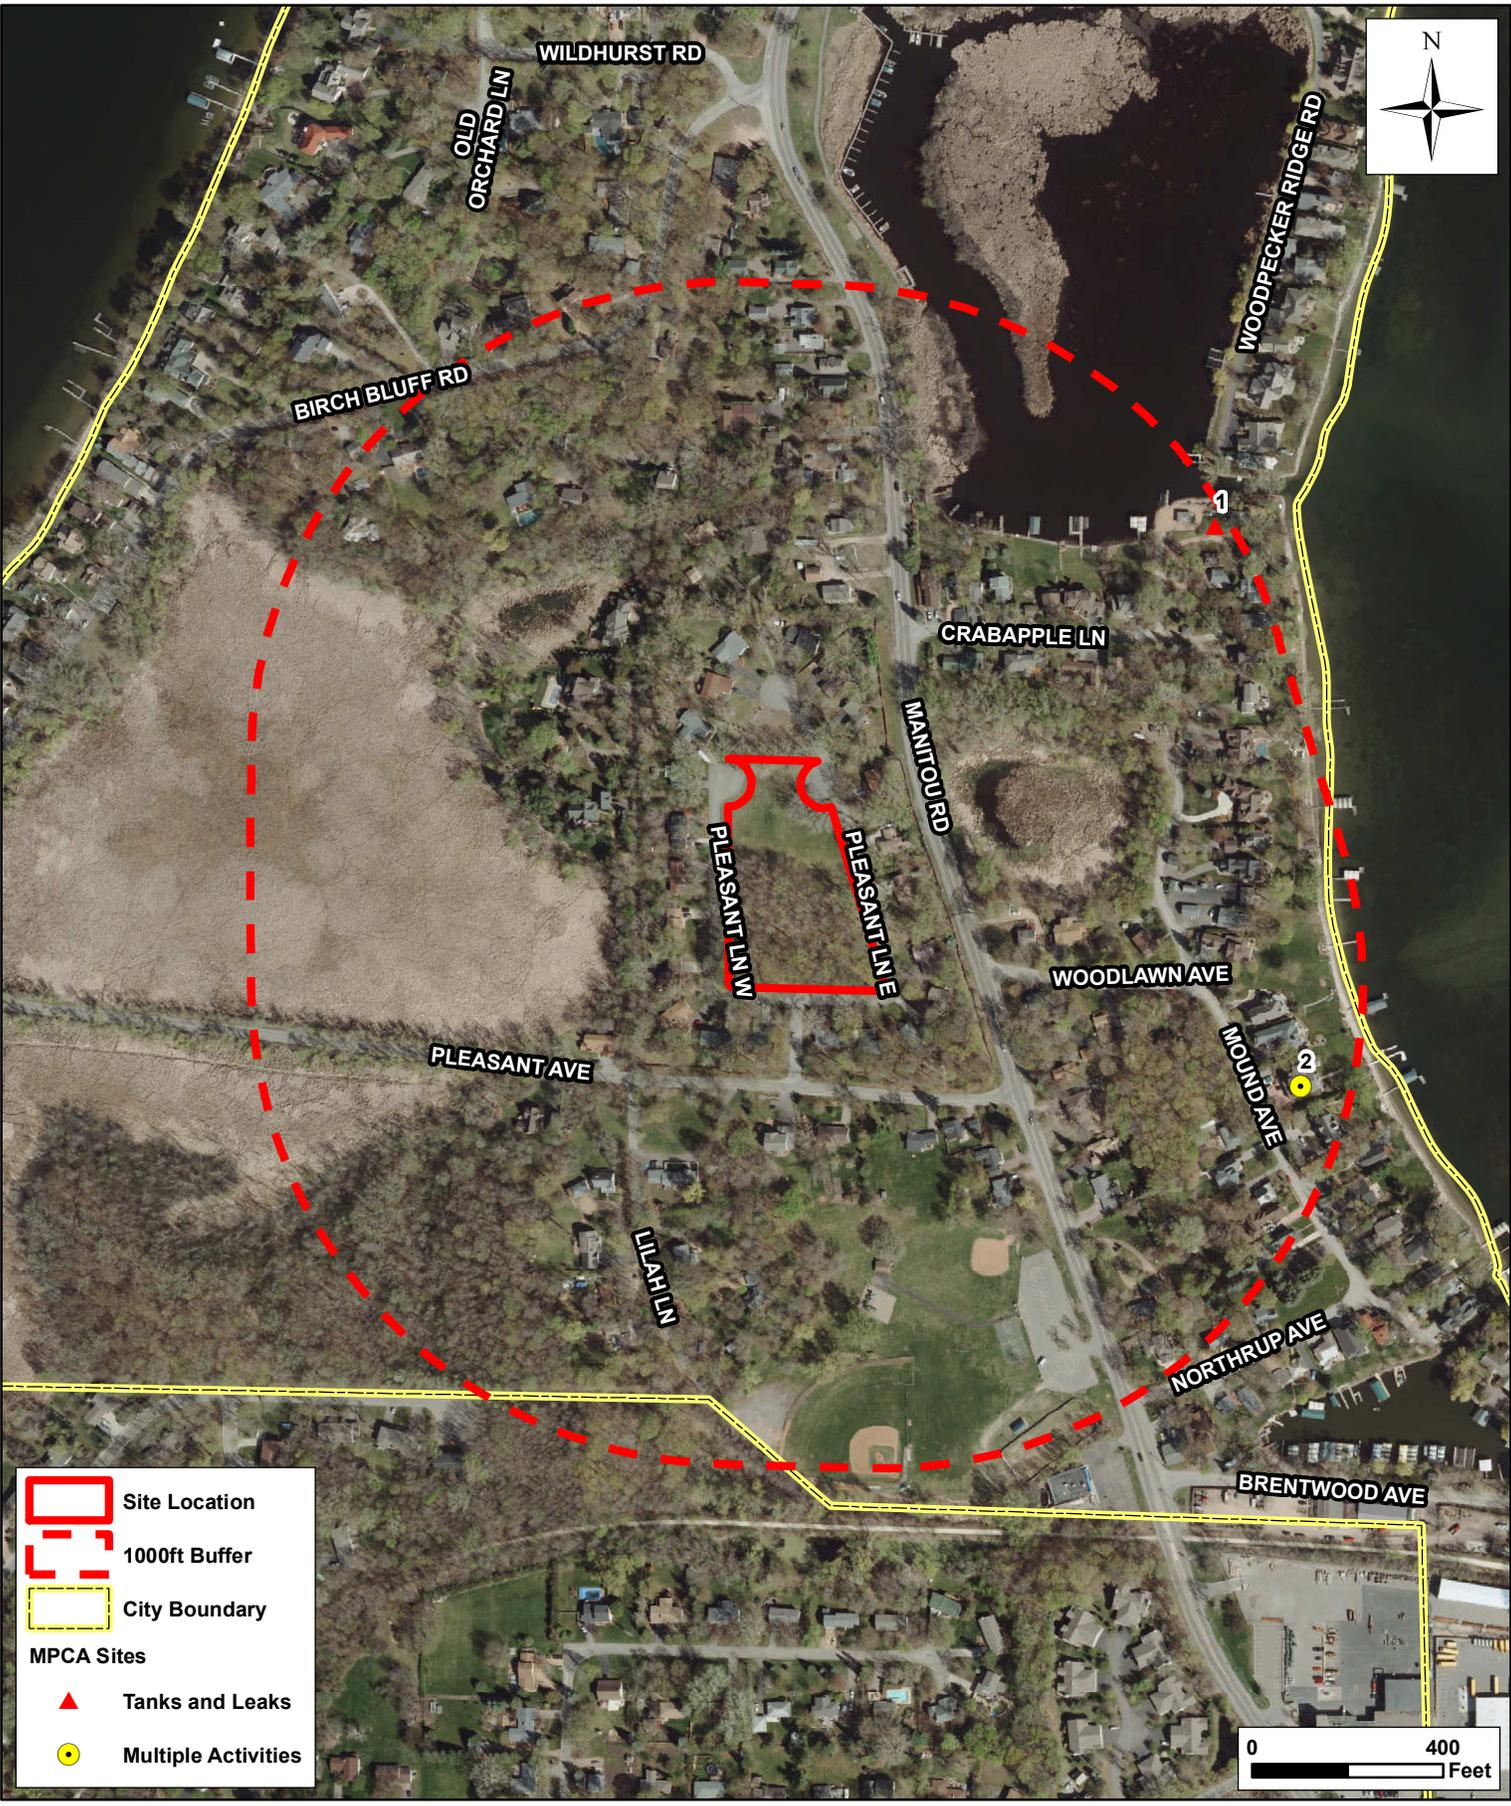
**Figure 3: Pleasant Park
What's In My Neighborhood Search Results
Tonka Bay, MN**

A review of the MPCA databases did not identify any listings for the Property or the adjacent properties. Two (2) MPCA database listings were identified within 1,000 feet of Property (beyond adjacent) and are identified in *Figure 3*. The surrounding area listings included:

- One (1) Leak listing
 - Indicates a petroleum tank leak has occurred at the site
- One (1) Multiple Activities listing
 - Indicates the site is present on more than one MPCA database. This multiple activity listing includes one petroleum leak site and one tank site.

The surrounding area listings identified in the MPCA database are at least 500 feet from the Property and have been issued site closure by the MPCA. Site closure does not indicate the site is free of contamination. Site closure does indicate that an investigation and/or cleanup has been completed and the leak has been determined not to pose a threat to human health or the environment. Based on their closed regulatory status and distance from the Property, it is unlikely that these sites have impacted the Property.

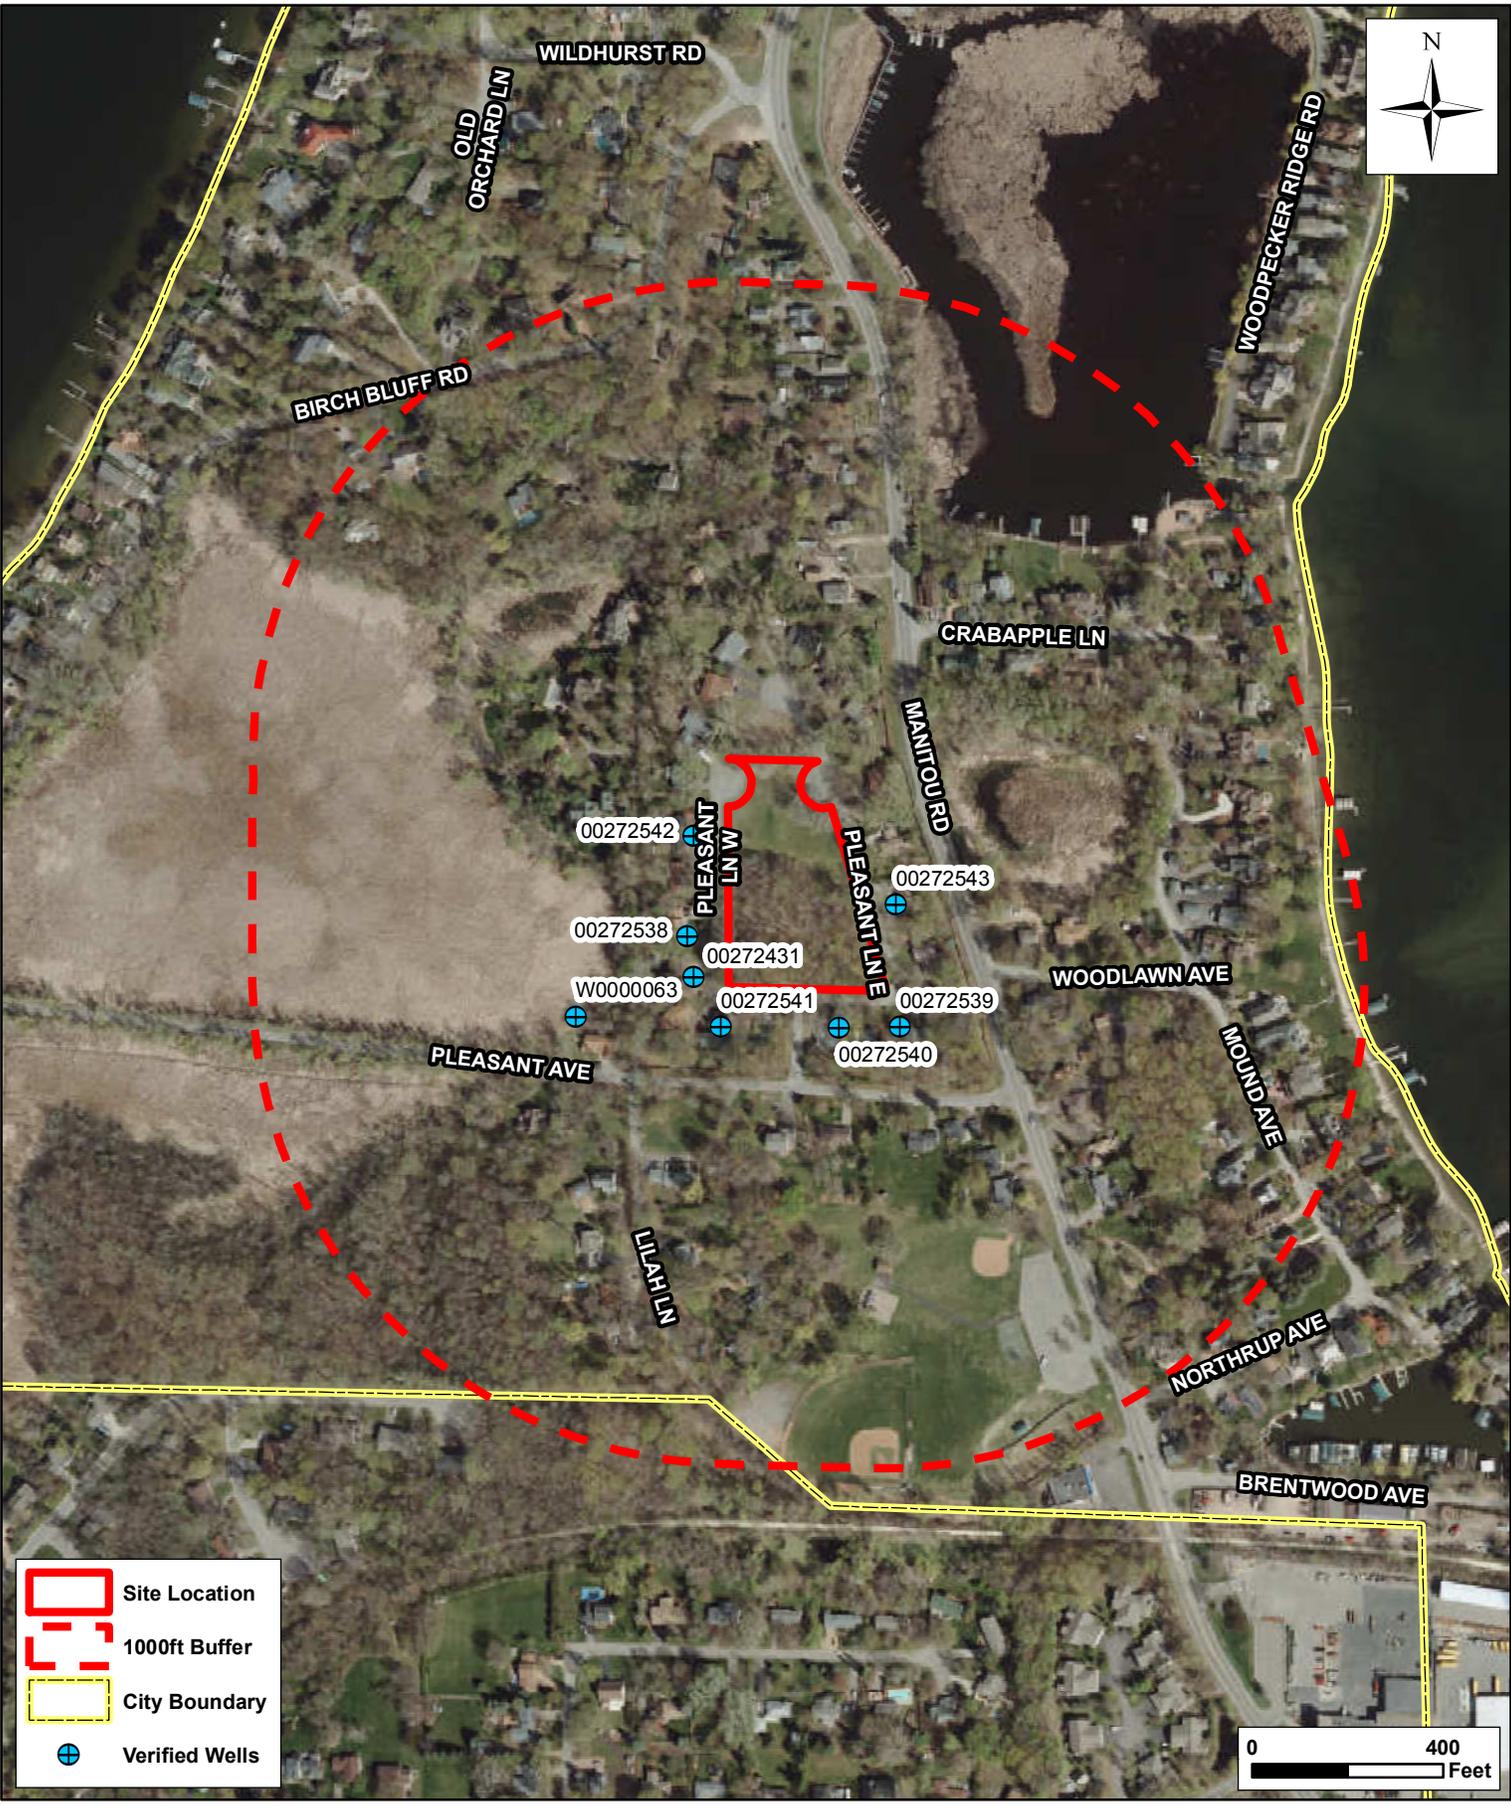
**Figure 4: Pleasant Park
County Well Index Map
Tonka Bay, MN**

A review of the MDH well database did not identify any listings for the Property. Seven (7) verified, domestic wells were identified to the south, east, and west of the Property. Static water levels in the adjacent wells ranged from 48 feet to 80 feet below ground surface and no fill material or debris was noted in any of the MDH well logs.

One (1) water well was identified in the MDH CWI within 1,000 feet of Property (beyond adjacent) to the southwest. The commercial well has a static water level of 8 feet below ground surface and no fill material or debris was noted in the well log. Well identification numbers and locations are depicted in *Figure 4*.

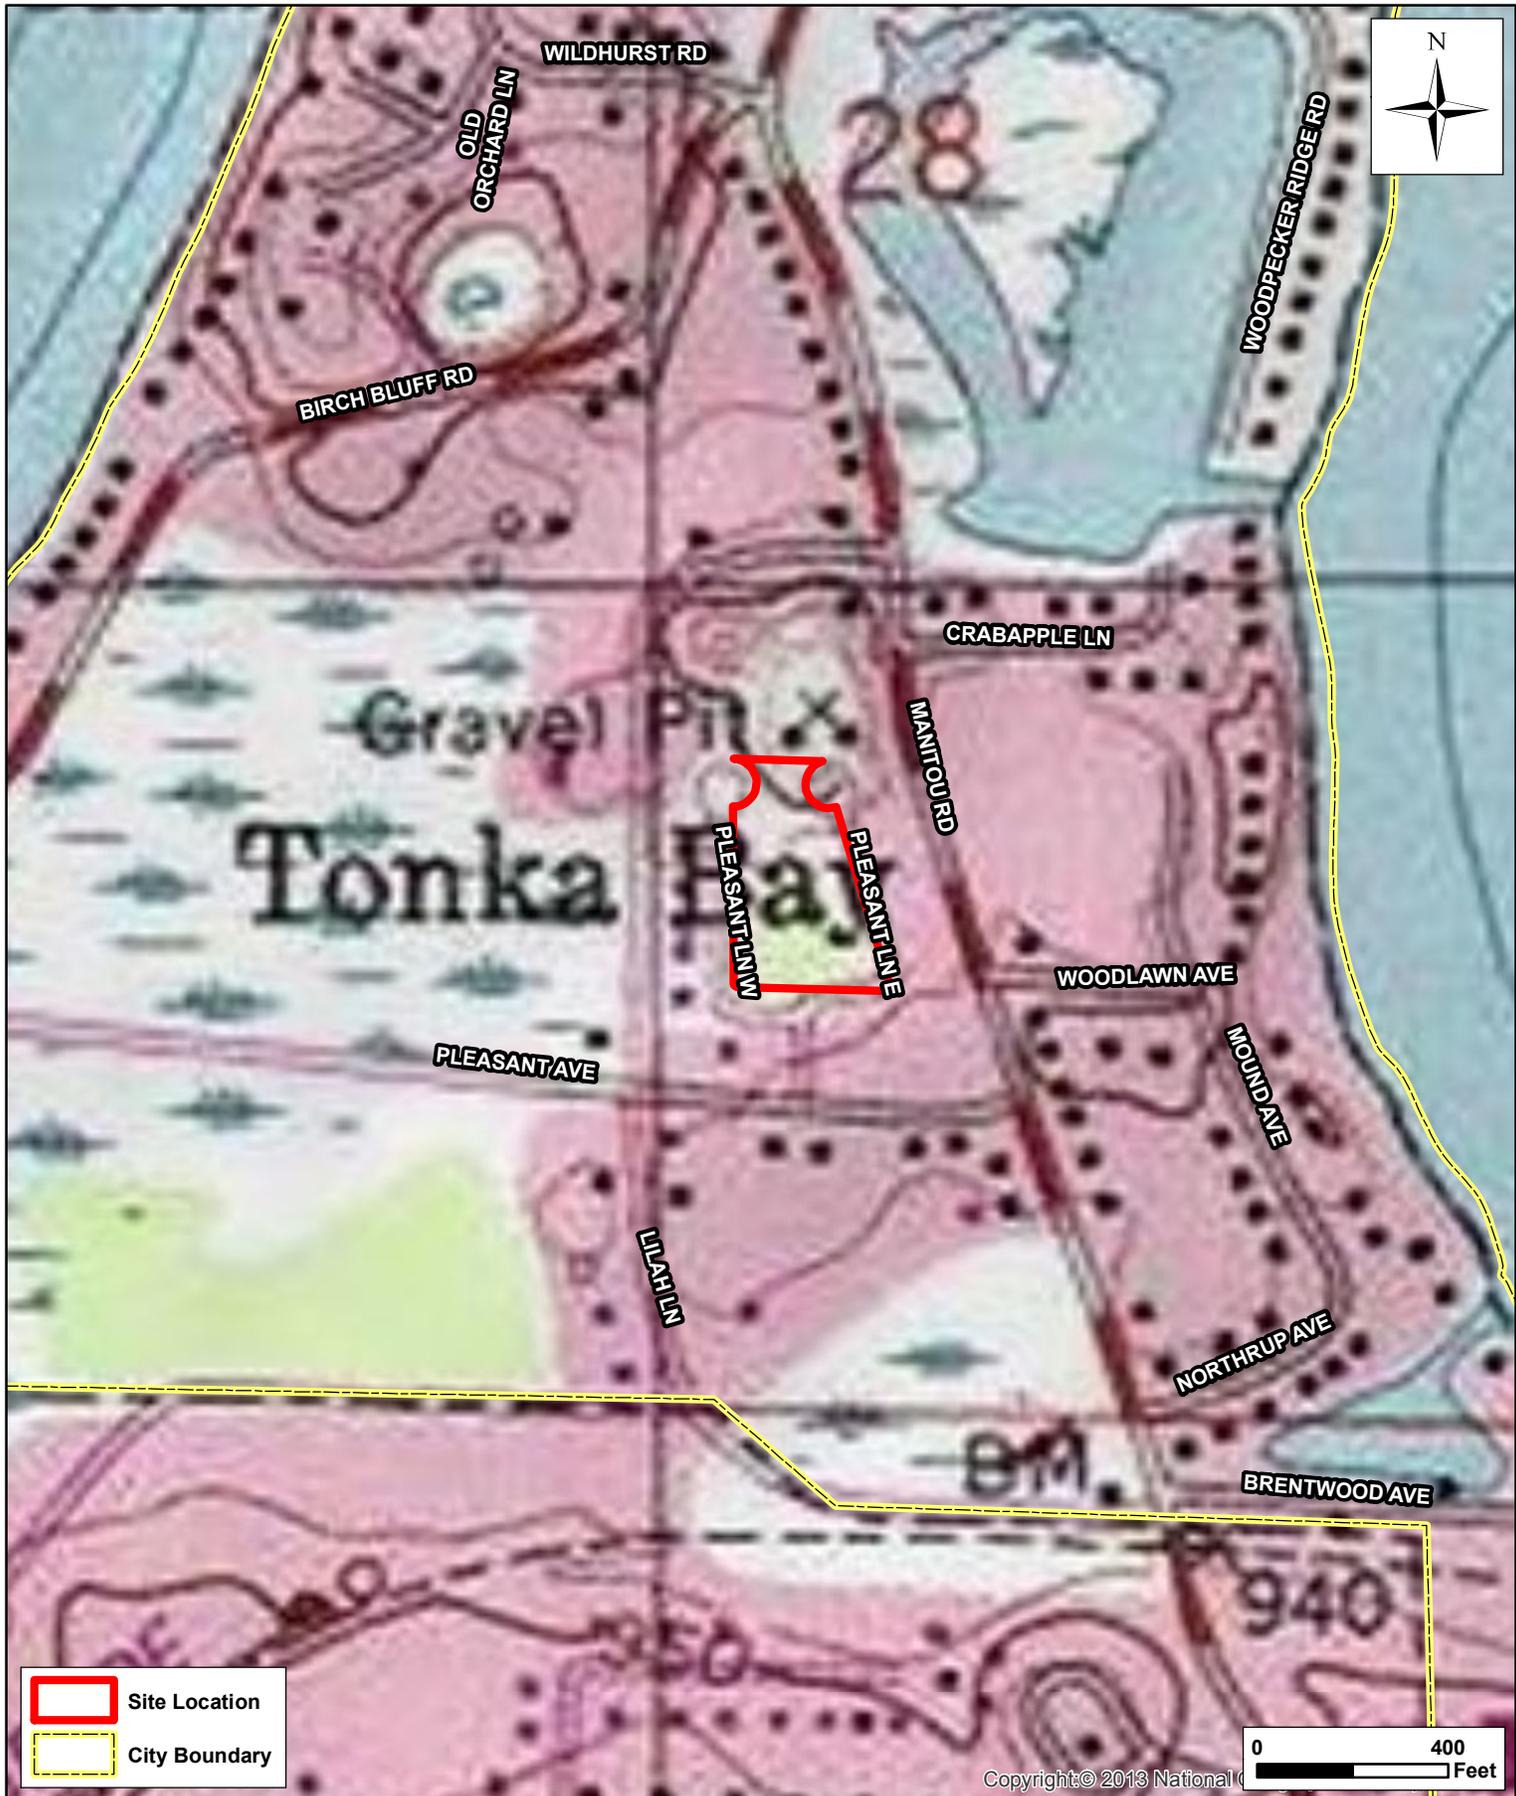
**Figure 5: Pleasant Park
USGS Topo Map
Tonka Bay, MN**

A review of the Minnesota DNR topographic maps identified a gravel pit located at the North side of the Property and northern adjacent property. The southern half of the Property is depicted as vegetated. Areas to the west and northeast are identified as marshes or swamps. Local features and Property topography are depicted in *Figure 5*.

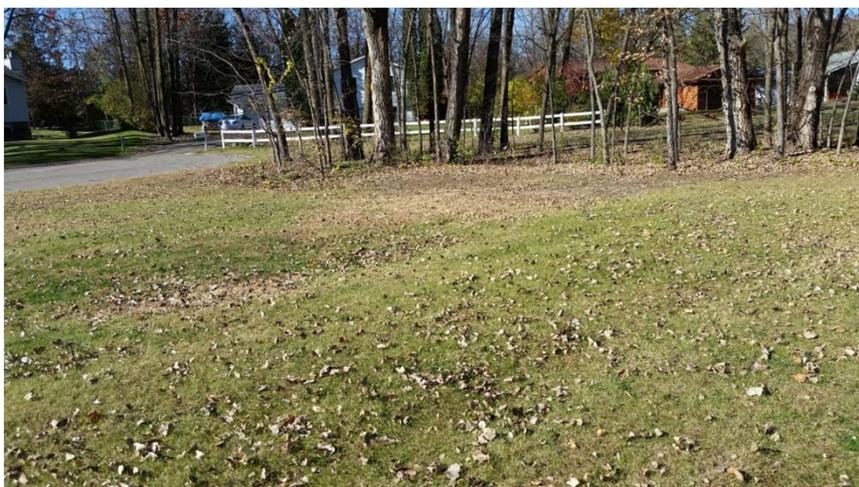
Photo 7 - View of distressed/dead grass and surface depressions at the northwest portion of the Property

Based on the findings of this memorandum, WSB recommends the completion of a Limited Phase II Environmental Site Assessment (Phase II) that includes approximately 6 to 8 test pits conducted in the depression areas at the north half of the Property. A sufficient number of test pits should be conducted to determine the general backfill sources/materials and approximate vertical and horizontal extents of the backfill material.

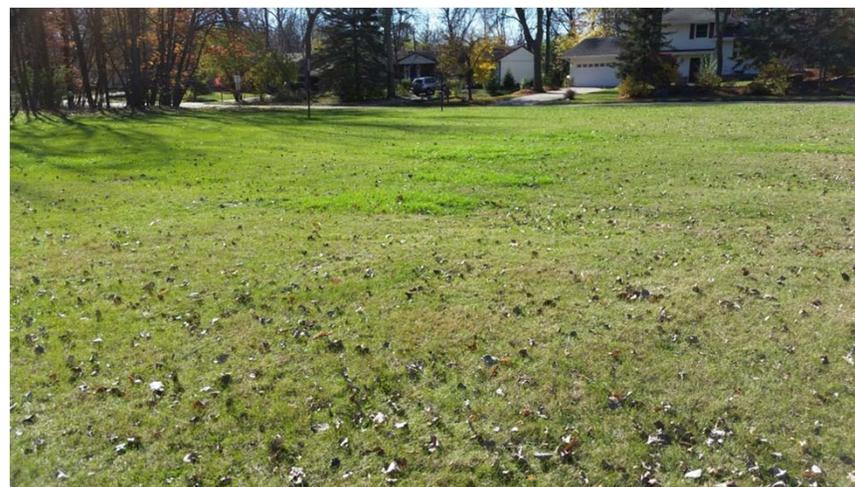
Photo 8 - View of newly planted grass patches at the Property

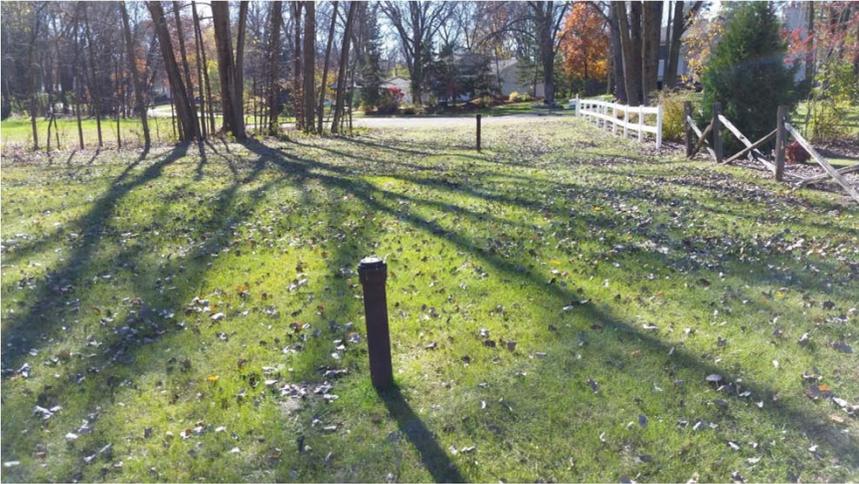
Photo 10 - Sewer clean outs at the north adjacent parcel

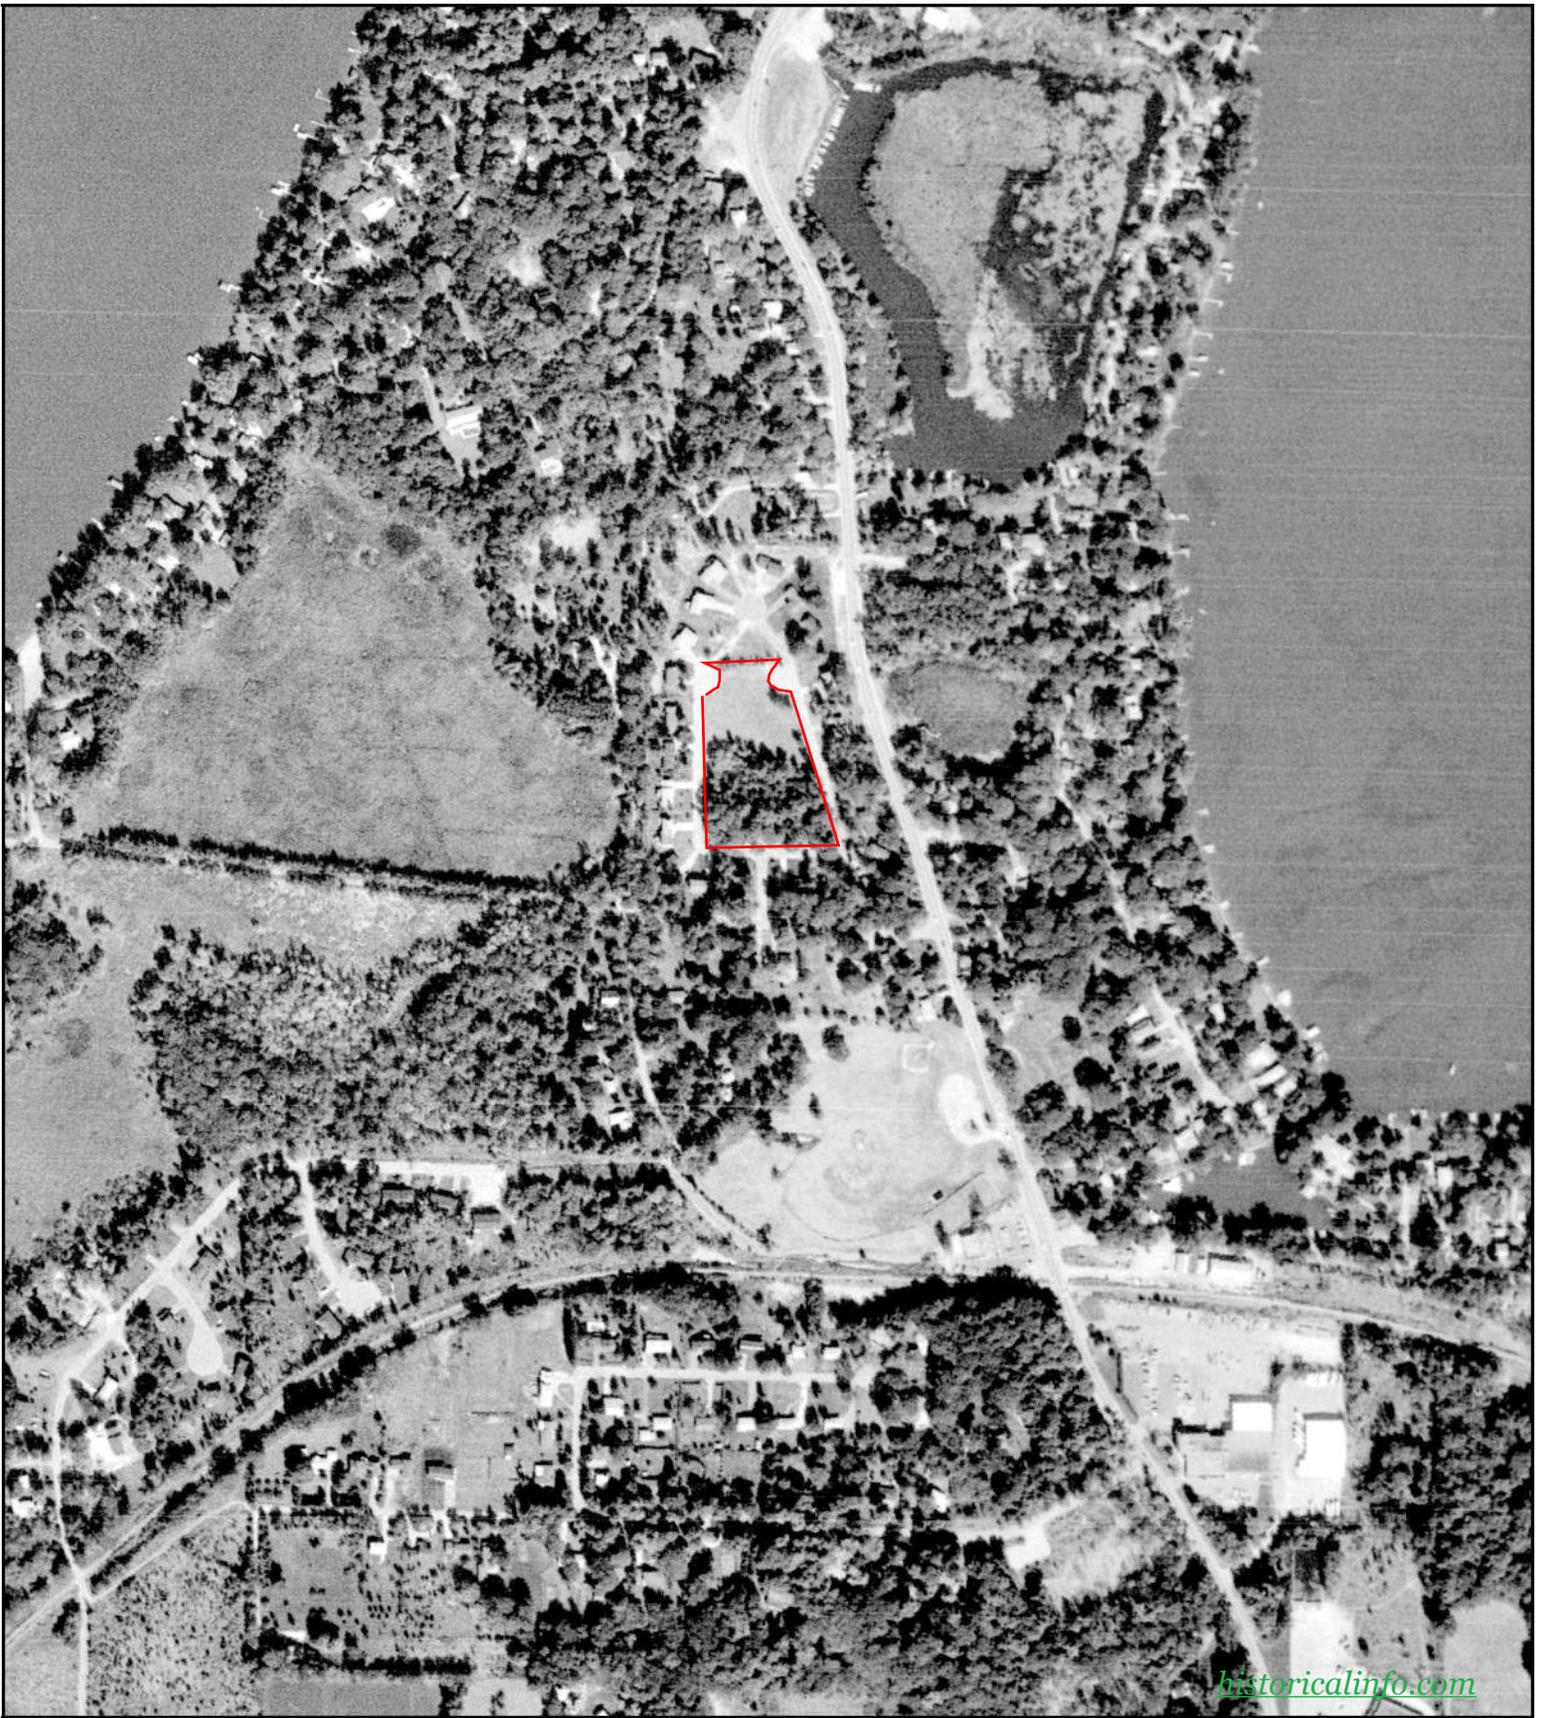
the northern portion of the Property in the 1953 to 1969 photographs. Noticeable deep depressions are present in the mining areas. After the 1969 aerial photograph, the ground disturbance at the northern half of the Property is no longer visible and is replaced with manicured grass and scattered trees in the 1979 and consecutive photographs.

North – The northern adjacent property is undeveloped land in the 1937 to 1947 photographs. Ground disturbance (likely gravel mining) started northeast of the Property in the 1937 photograph and expanded south and west onto the Property through the 1969 photograph. The 1979 aerial photograph shows the area to the north developed as residential properties.

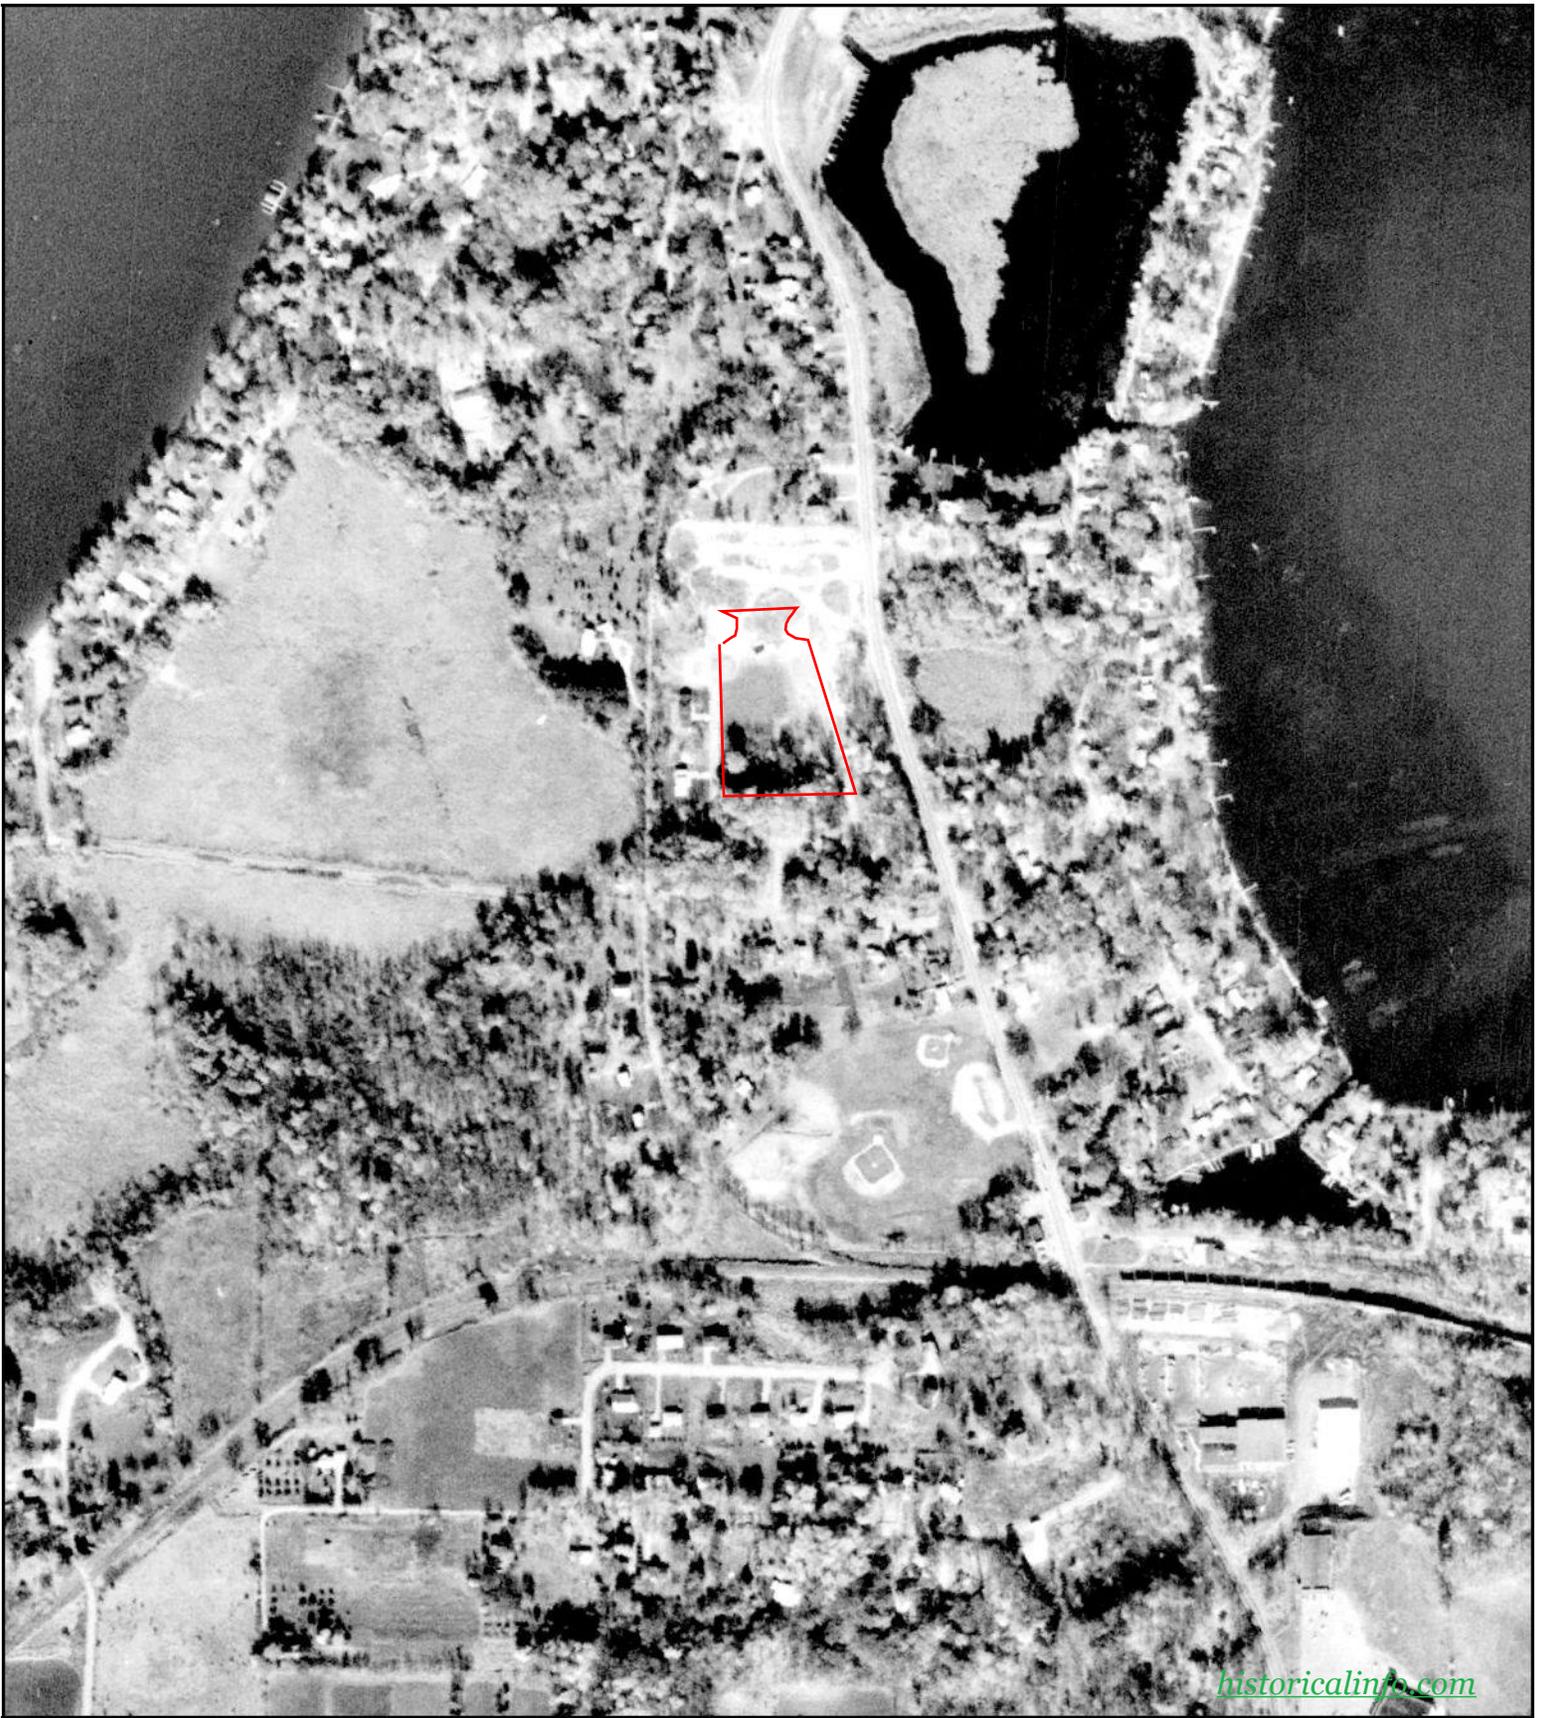
The southern half of the Property was undeveloped land in the 1937 and consecutive photographs. Ground disturbance, from what if most likely a gravel mining operation, is visible at the east central portion of the Property in the 1937 to 1969 photographs and at
